MC CONNELL LAKE DAM

NDI NO. PA-00398

PHASE I INSPECTION REPORT NATIONAL DAM INSPECTION PROGRAM

JUNE 1980

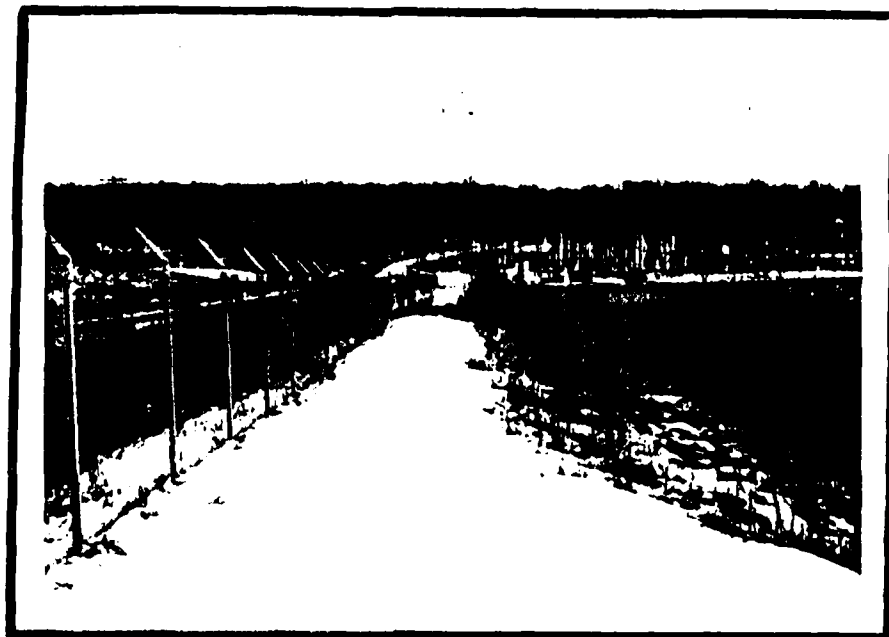
LEFT END OF EMBANKMENT - NO. 2

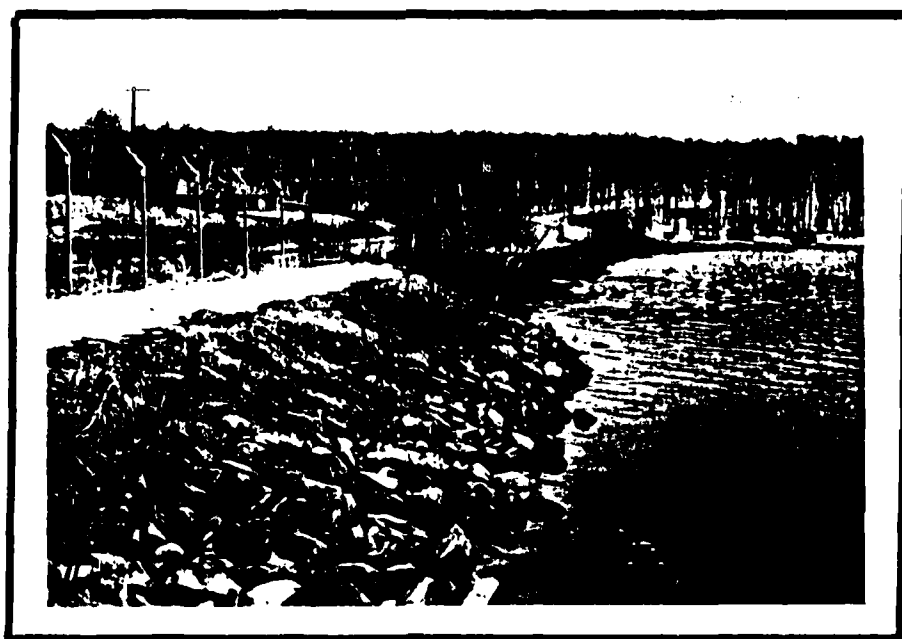
The upstream slope is in fair condition. Good riprap protection is on the upstream slope to prevent damage from wave action. Some heavy brush and small trees are growing on this slope.

UPSTREAM SLOPE - NO. 3

2. That all brush and trees be removed from the embankment slopes and that this maintenance be repeated on a regular basis.
3. That at least the two top valves be greased and operated on an annual basis.
4. That a formal surveillance plan and downstream warning system be developed for implementation during periods of high or prolonged precipitation.
5. That an operation and maintenance manual be prepared for guidance in the operation of the dam during normal and emergency conditions, and that a schedule be developed for the annual inspection of the dam and its appurtenant structures.

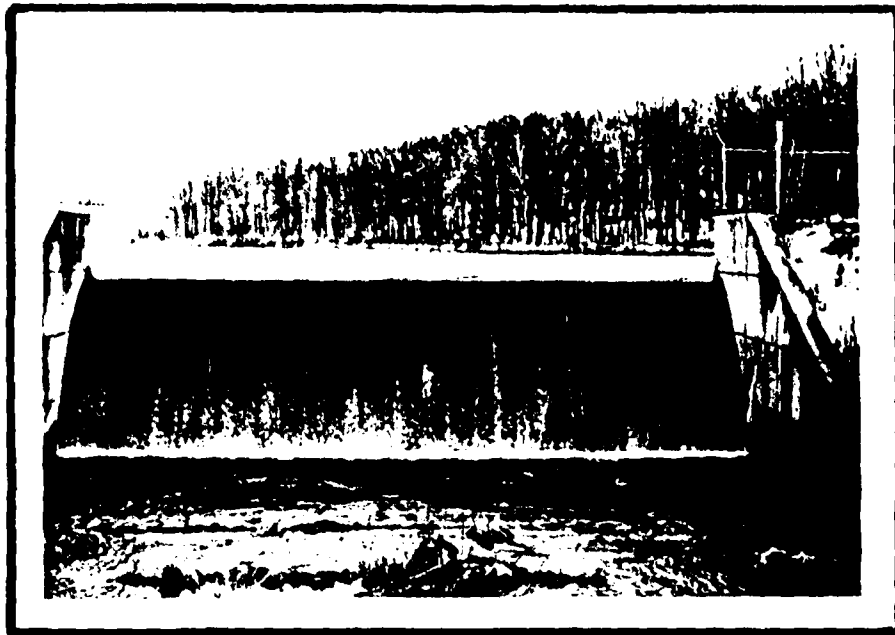
The concrete ogee section appeared to be in good condition with no signs of deterioration of the concrete. The abutment walls had some minor cracking (Photographs No. 1 and No. 4). There was, however, no movement or deflection and the cracking is not considered to be serious at the present time.

The ogee spillway and wingwalls are founded on a 1.5 foot thick slab which is shown to be supported on 20 foot long timber piles. The maximum height of the wingwalls is 19 feet with a footing width of 8.33 feet. This width appears to be small, but there is no apparent stability problem. The abutment walls adjacent to the ogee section appear to have no footings at the right side and only a partial footing at the left side. This condition could contribute to some of the observed cracking.

B. WEIR: Crest Condition Cracks Deterioration Foundation Abutments	Ogee section in good condition. Walls are plumb and also in good physical condition. A wet area was noted on the left wall about 8'± from the top. Some vertical cracking in abutment walls due to unequal stresses.

OGEE SPILLWAY - NO. 4

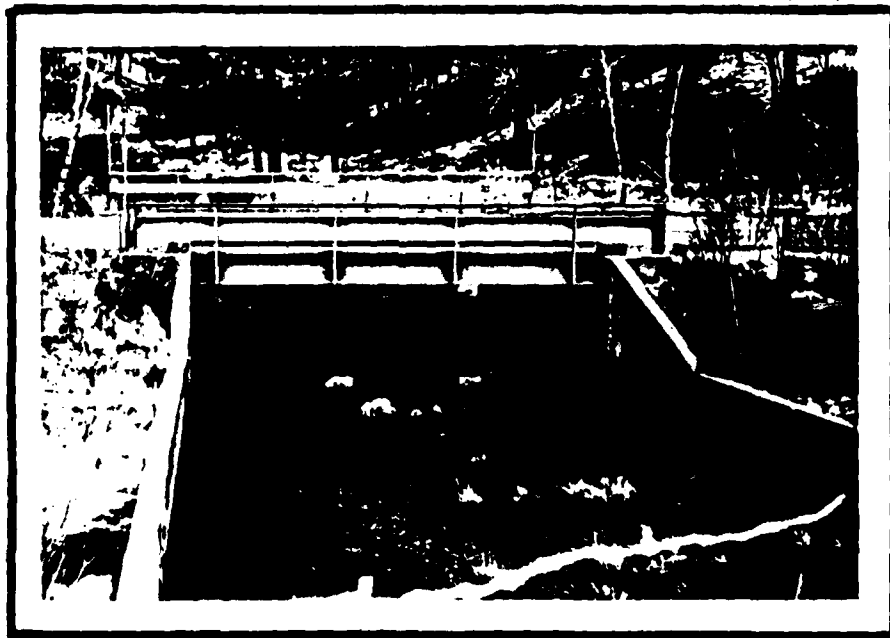
The spillway discharge channel is a U-shaped channel with concrete walls and slab. The concrete was in good condition. A steel beam highway bridge crosses the discharge channel about 110 feet downstream from the ogee section (Photograph No. 5).

BRIDGE OVER CHANNEL BELOW SPILLWAY - NO. 5

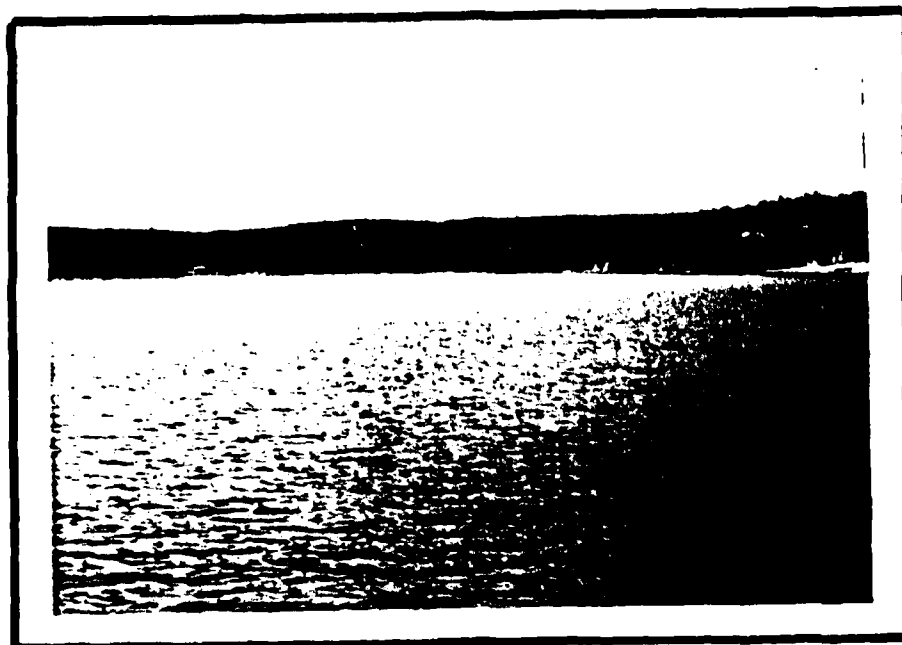
RESERVOIR - NO. 7
